Tail Lamps and Side Lamps

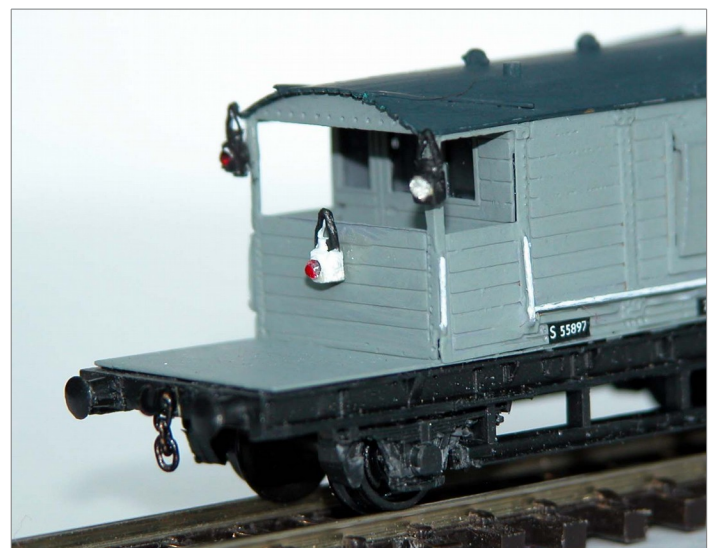
The photo on the left shows a BR period unfitted brake with lights appropriate for running on the slow line next to the fast line. One light has been changed from white to red by painting it with Artists vermilion oil paint: this is translucent so looks better than ordinary enamel as the jewel still reflects light.

The colours to be shown to the rear depended on the track the train was on (quite a challenge to change these when your train crosses between tracks!). Usually both would show red to the rear. However, if running on the slow line (of a 4 track line) or on a relief line or goods loop next to the mainline, the light on the side nearest the main line had to be white (if the colour shown could not be changed, the lamp had to be removed). A train on a relief line next to a slow line (i.e. the third parallel line running in the same direction) would show two red lights.

Finally, in OO or N if you never intend to couple anything to the rear of the brake van, why not remove the ugly automatic coupling? If you want, add a dummy 3-link coupling such as the ones produced by Scalelink as shown.
