Tail Lamps and Side Lamps

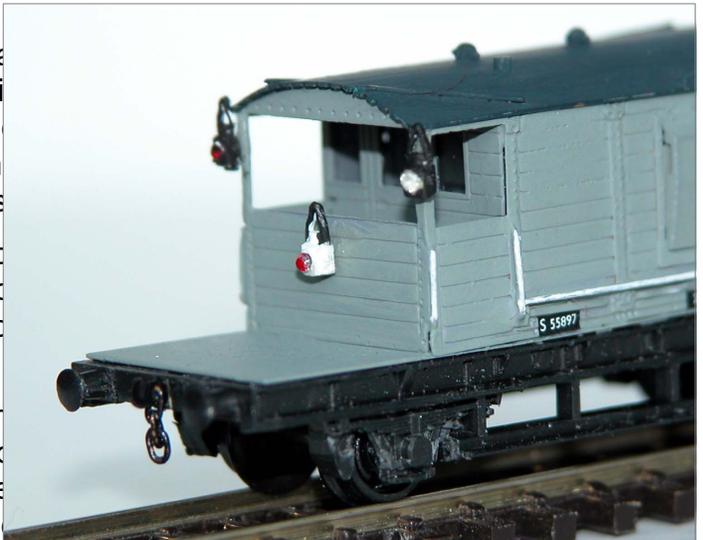
The photo on the left shows a BR period unfitted b slow line next to the fast line. One light has been c Artists vermilion oil paint: this is translucent so loc reflects light.

Finally, in OO or N if you never intend to couple anything to the rear of the brake van, why not remove the ugly automatic coupling? If you want, add a dummy 3-link coupling such as the ones produced by Scalelink as shown.
