12T Covered Vans (XP Rated)

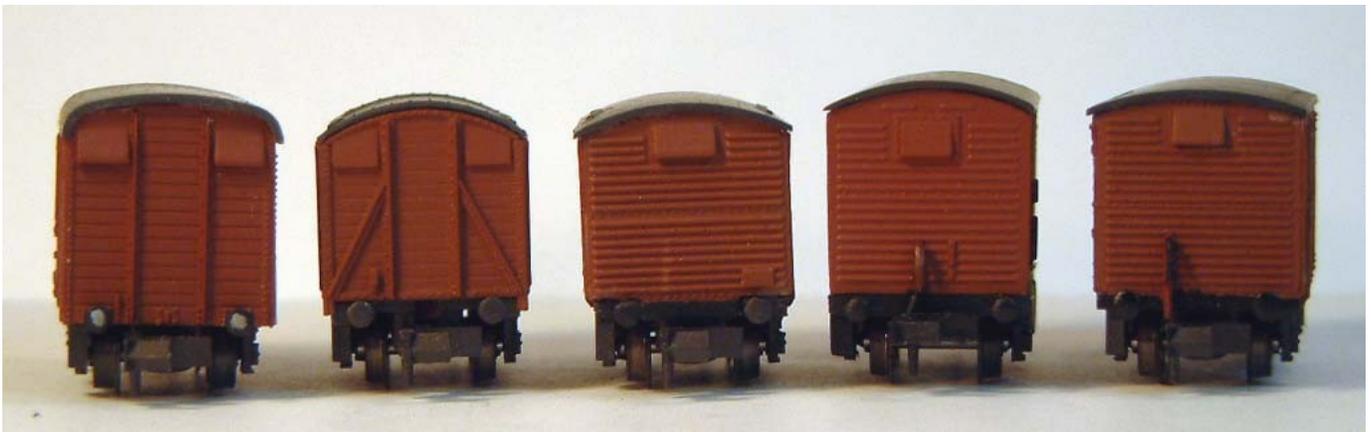
The roof shape is one of the easiest ways of distinguishing vans in photographs. The SR vans have a very distinctive elliptical roof, the corners of which are higher than other vans. The others all have plain curved roofs but with different curvature, GWR most curved, then BR standard vans, then LNER, and the flattest is the LMS – though there is little difference between the LMS and LNER vans. The photo below shows, from the left, the ends of SR, GWR, BR, LNER, and LMS vans.
